ALLSTAR TECHNICAL NOTE

Product: Allstar 6000, 6500 and PDQ
Subject: Intermittent Reversing and Work Lamp Problems

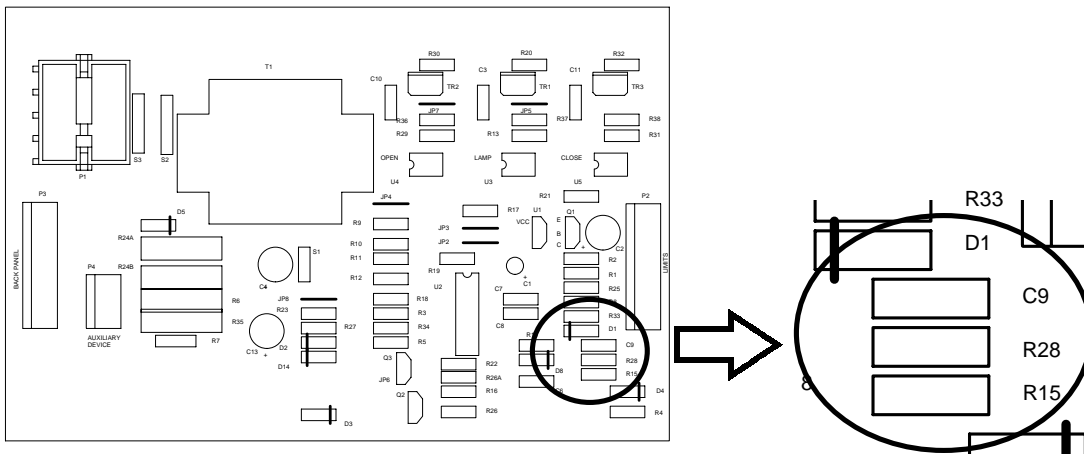
Under some combination of field conditions and normal component tolerance variations, the operator stops and reverses or just stops in mid travel and sometimes the work lamp will turn off before the 4-1/2 minute delay. Only a very small number of operators exhibit these symptoms and typically they show-up during installation.

Testing indicated that an unusually high level of electrical noise could affect the timing of the control logic. In most installations, this problem was resolved by removing C9 from the motor control board (see diagram below). The removal of C9 was implemented as a running change to the motor control in January 2001.

Additional field reports and subsequent testing indicated additional improvement was required and a minor component change was implemented to improve the timing logic. The value of resistor R28 was changed from 6.8K to 22K. As of February 19th, 2001 any motor controls in-house (used for production or replacement or repair) were reworked with this change.

A 22K resistor (red, red, orange, gold) is inserted into the C9 position and R28 is cut off the board.

C9 is cut off the board and a 22K (red, red, orange, gold) resistor is inserted into the R28 position.

If a “mustard yellow” capacitor is in the C9 position and/or R28 is 6.8K (blue, gray, red, gold) the control board has not been upgraded. Contact customer service if a replacement is required.

To identify a control with the latest changes look for the following (see diagram below):
