NORTEK CONTROL PRODUCT BULLETIN 10/09/2020

Multi Code Visor TX Case Plastic

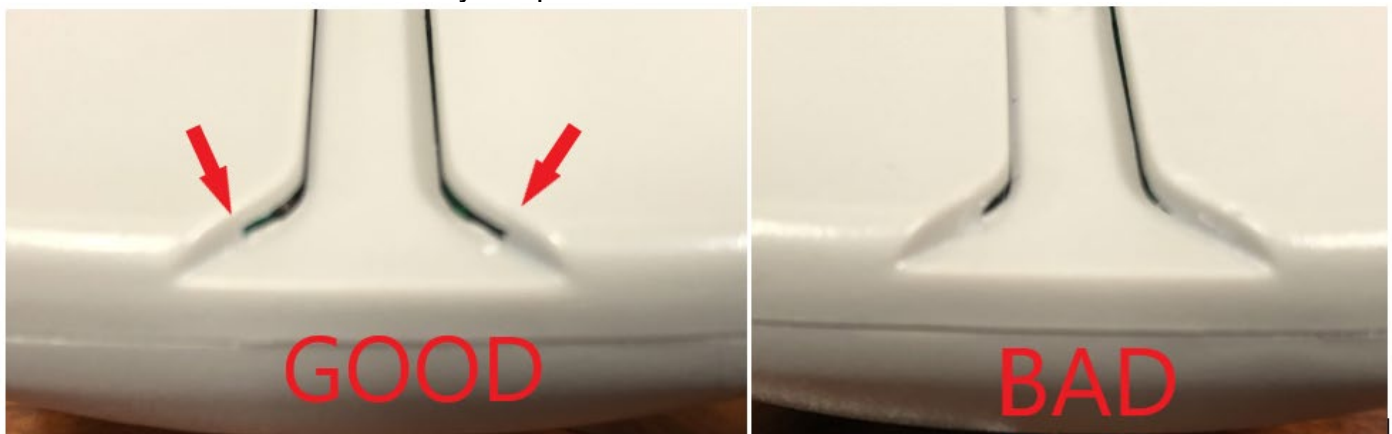
It has been brought to our attention that a number of our Multi Code transmitters have had problems fitting the included metal visor clip. The issue is with the case bottom where the visor clip slides into the case. On problematic units, there is excessive plastic in the slot preventing the visor clip from sliding into place.

A single cavity among one of the several plastic molds used to produce the case halves has been identified as the culprit and appropriate corrective actions have been implemented in production.

Here is a visual on how to identify the problematic case:

Affected products can be returned to Nortek Control via the standard returns process.
