PERS-4200 Supervisory Reporting

Summary

PERS-4200 Console

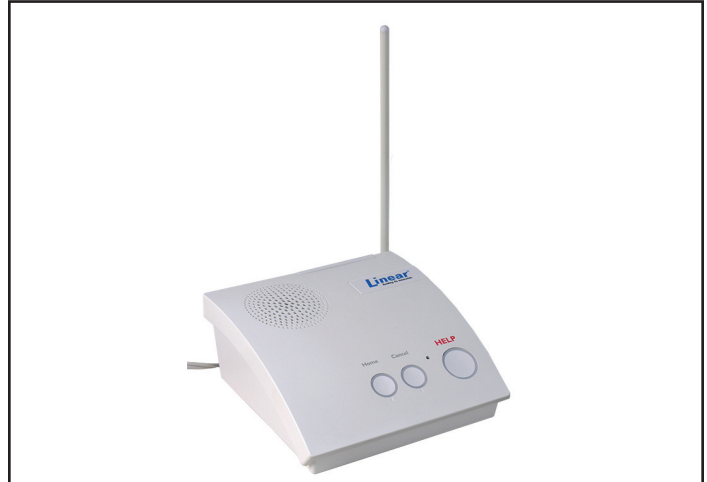
A summary of the supervisory related items is reprinted below:

EVENT DESCRIPTION	REPORTING CODE			
	CID		4 X 2	SIA
	Group	Partition (Ext)		
CONSOLE SUPERVISORY (RECEIVER BOARD TROUBLE)	1381	00	40	MS
CONSOLE SUPERVISORY RESTORE	3381	00	40	MJ
FIRE (SMOKE) SUPERVISORY	1200	XX ^[2]	40 + SENSOR #	FS
FIRE (SMOKE) SUPERVISORY RESTORE	3200	XX ^[2]	40 + SENSOR #	FQ
CO SUPERVISORY	1381	XX ^[2]	40 + SENSOR #	GS
CO SUPERVISORY RESTORE	3200	XX ^[2]	40 + SENSOR #	GQ
EMERGENCY SUPERVISORY	1381	XX ^[2]	40 + SENSOR #	MS
EMERGENCY SUPERVISORY RESTORE	3381	XX ^[2]	40 + SENSOR #	MJ

See the table of Event Descriptions provided in Appendix A, Page 34 of the Installation & Programming manual (P/N 231003).
